NATIONAL PROGRAM FOR INSPECTION OF NON-FEDERAL DAMS  
UPPER SACKETT RESERVOIR (U) CORPS OF ENGINEERS WALTHAM  
MA NEW ENGLAND DIV AUG 81

PHASE I  
NATIONAL DAM INSPECTION PROGRAM

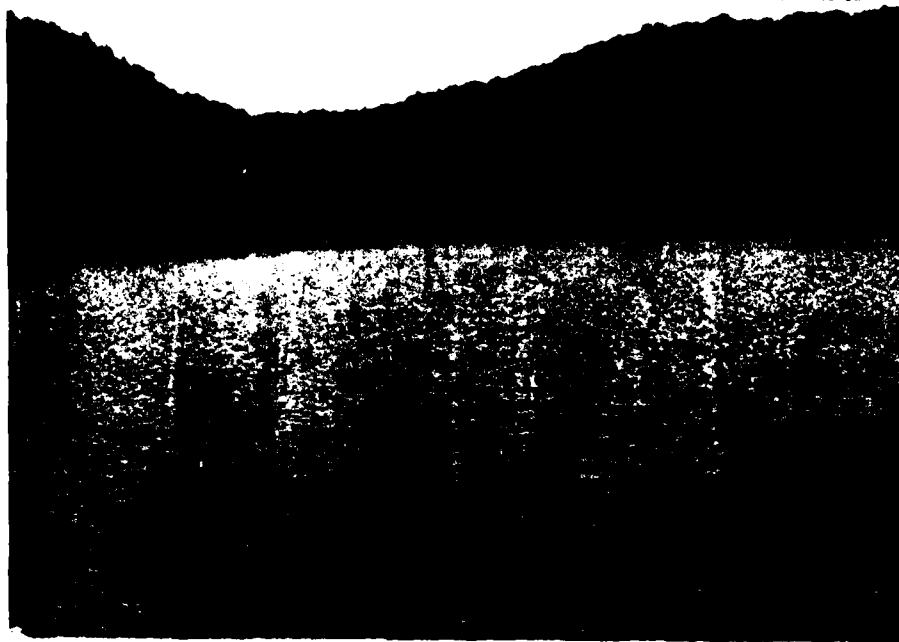
PHOTO NO. 1 - Upper Sackett Reservoir viewed from spillway crest.

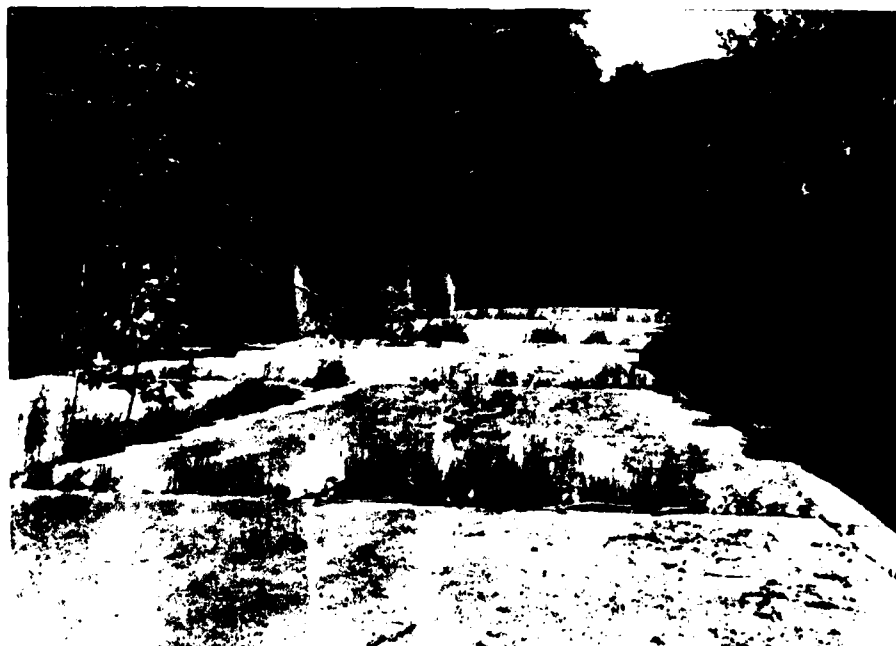
PHOTO NO. 2 - Concrete spillway channel viewed from spillway weir.

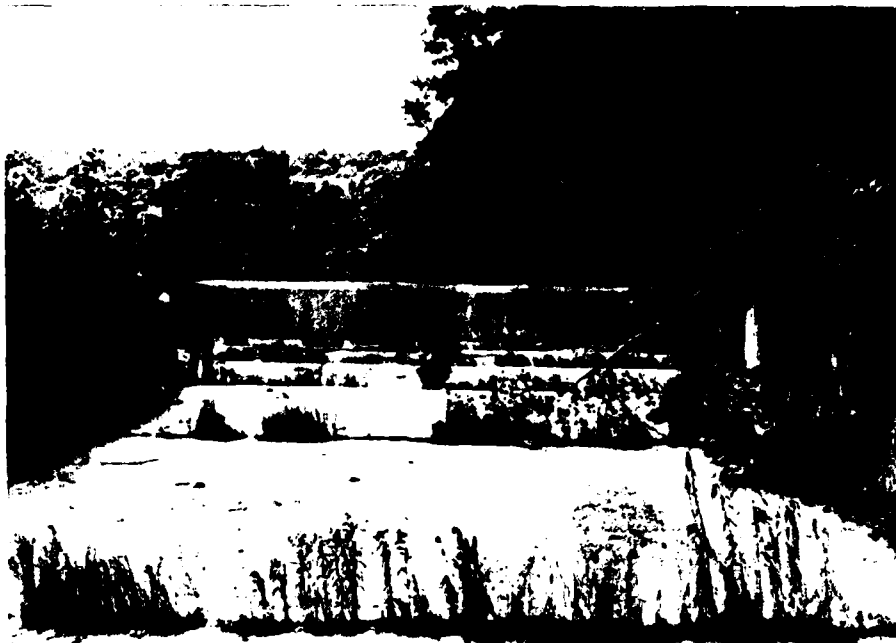
The downstream concrete spillway apron is in good condition except for vegetation growing in the joints (photograph 3).

PHOTO NO. 3 - View of spillway channel, wingwalls and weir.

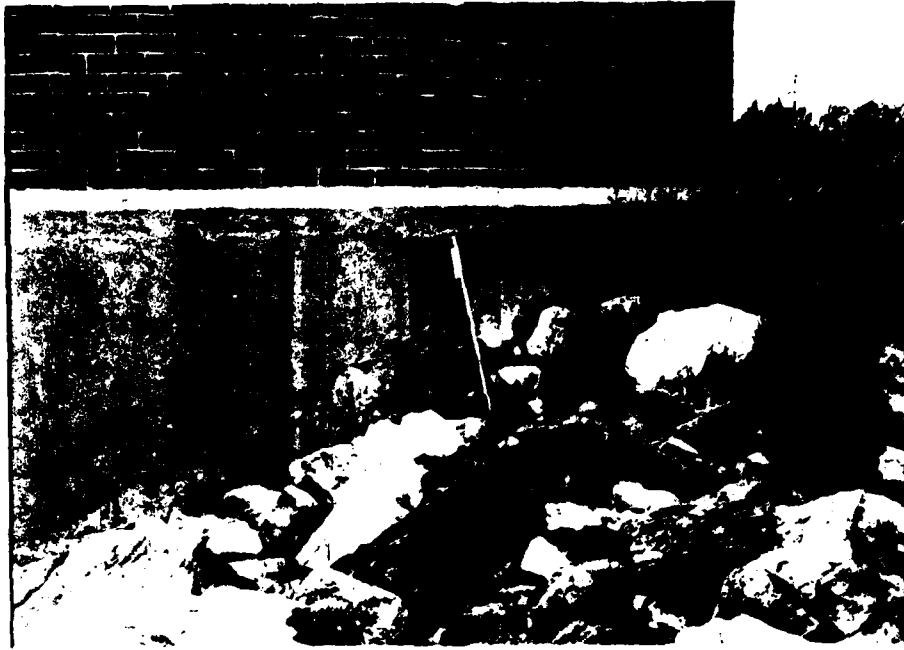
the upstream slope may have subsided somewhat, as shown in photograph 11. It appears that the foundation wall of the gate structure was resurfaced with mortar in the past and that the riprap has settled as much as 10 inches below the area that was resurfaced.

PHOTO NO. 11 - Base of gate structure where masonry finish on gate structure suggest that settlement of crest has occurred. However, subsidence in this area not obvious.

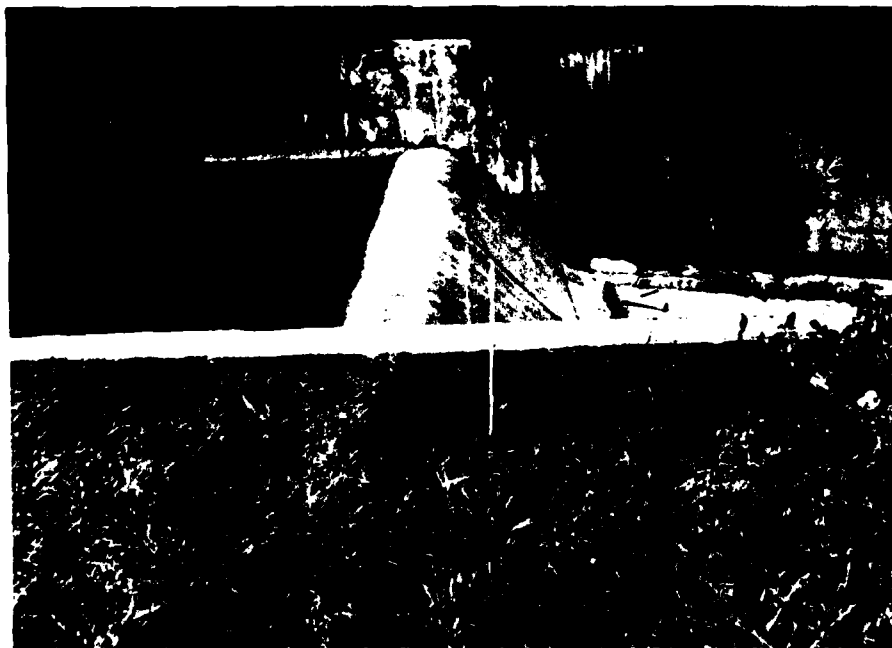
PHOTO NO. 12 - Spillway weir and settlement of crest up to 1 foot just behind right wall of spillway.

It is recommended that the Owner engage a qualified registered professional engineer to investigate and design required remedial measures for: the source of seepage at the downstream toe; the crest subsidence near the right spillway wall and gate structure; the cause of surficial sloughs on the downstream slope; a means of removing and backfilling trees and roots; evaluating the condition of the 24 inch drain to assure the gate is operable and repair of the leak in the spillway weir.
